# Manhole Inspection Summary

Manhole # S31I\_\_033MH

Insp Date: **10/29/08 2:18 PM**

**Location** Address: **321 s eutaw st**

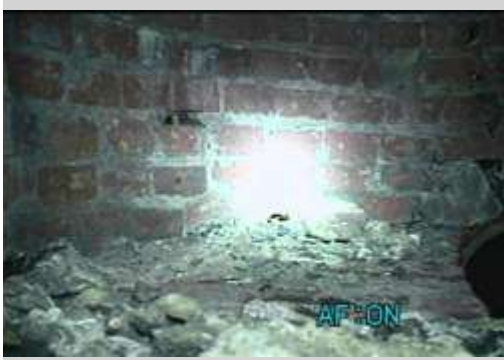
Defect 4

Condition: ☐ Sound ☐ Cracked ☐ Root Intrusion ☐ Deteriorated ☐ Leaks ☒ **Debris**

bench debris

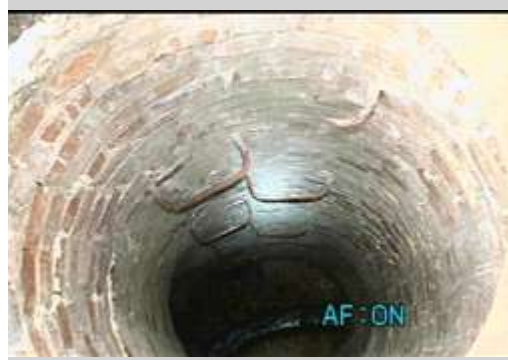
Defect 3

**Steps** Count: **10** Missing: **5** ☒ **Corroded**

corr steps

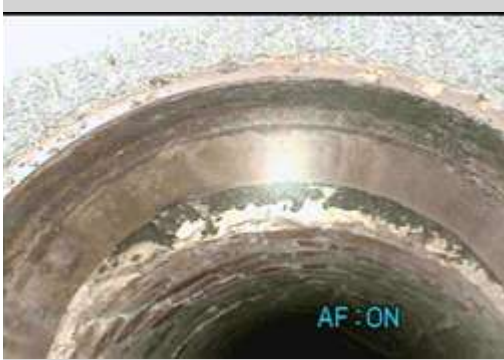
Defect 2

**Frame** Offset: **2** (in.) Condition: ☒ Sound ☐ Cracked ☐ Leaks

offset

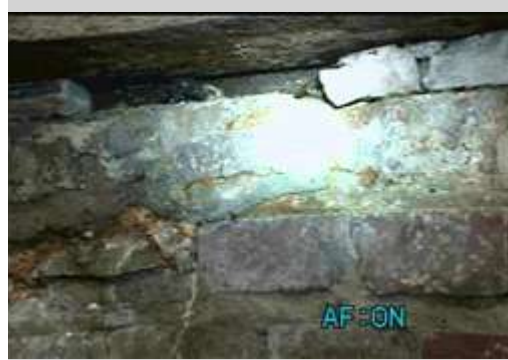
Defect 1

Condition: ☐ Sound ☒ **Cracked** ☐ Root Intrusion ☒ **Loose Brick** ☒ **Deteriorated**

chimney cracked, loose bricks

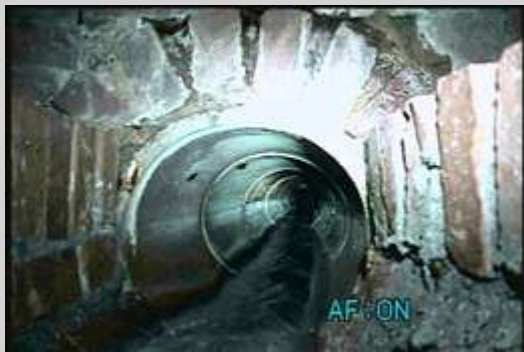
12 O'Clock Outflow

10 in. Circular Gravity Sewer  
Pipe Out @ 12 O'Clock

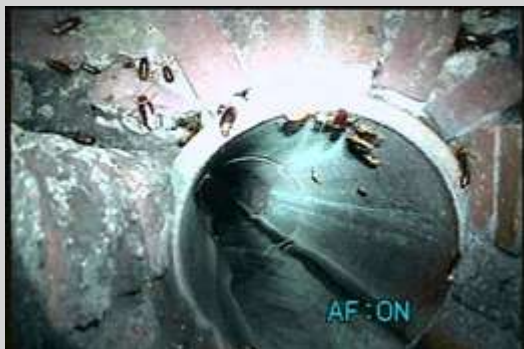
5 O'Clock Inflow

10 in. Circular Gravity Sewer  
Pipe In @ 5 O'Clock
